2THECORE HOME INSPECTIONS

2THECORE RESIDENTIAL

1234 Main Street
Cape Carteret, NC 28584

Buyer Name
11/28/2023 9:00AM

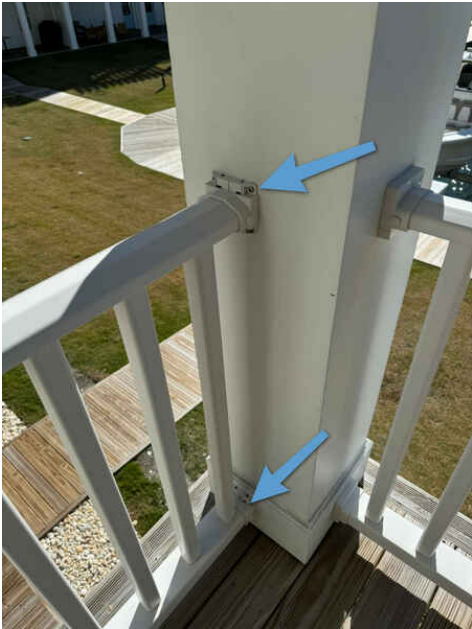
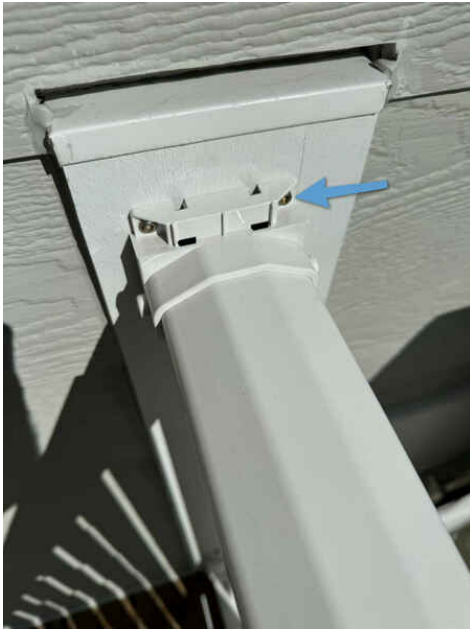
4.4.1 Guardrails, Stair Rails, & Handrails

GUARDRAIL - MISSING BRACKET COVER

Contact a qualified professional.

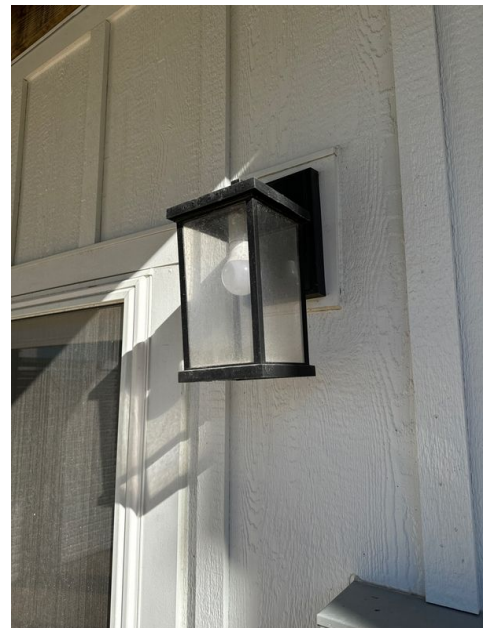
5.10.1 Exterior Issues

EXTERIOR LIGHT LOOSE

Contact a qualified professional.

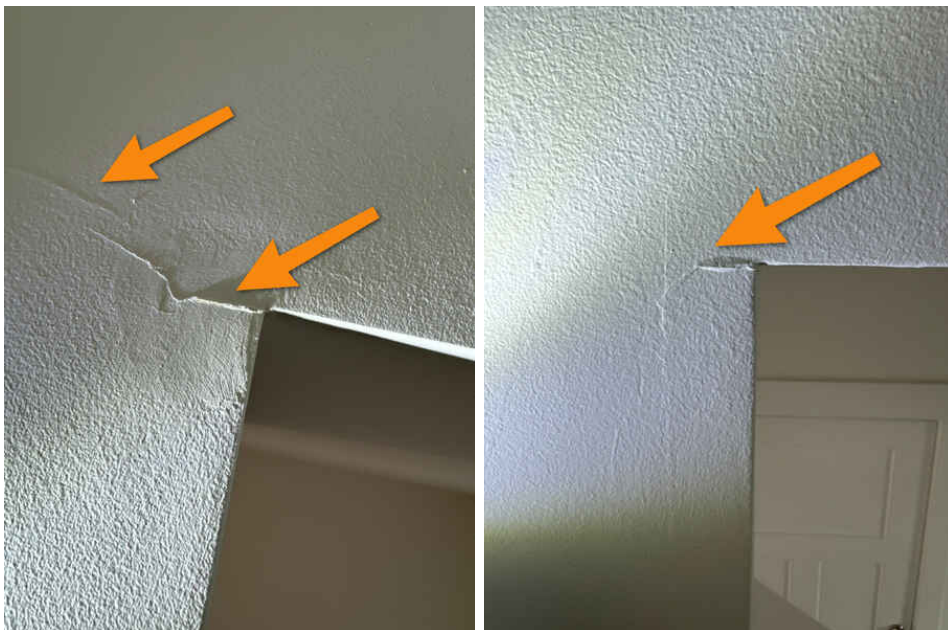
8.4.1 Walls

Repair Needed

Contact a qualified drywall contractor.

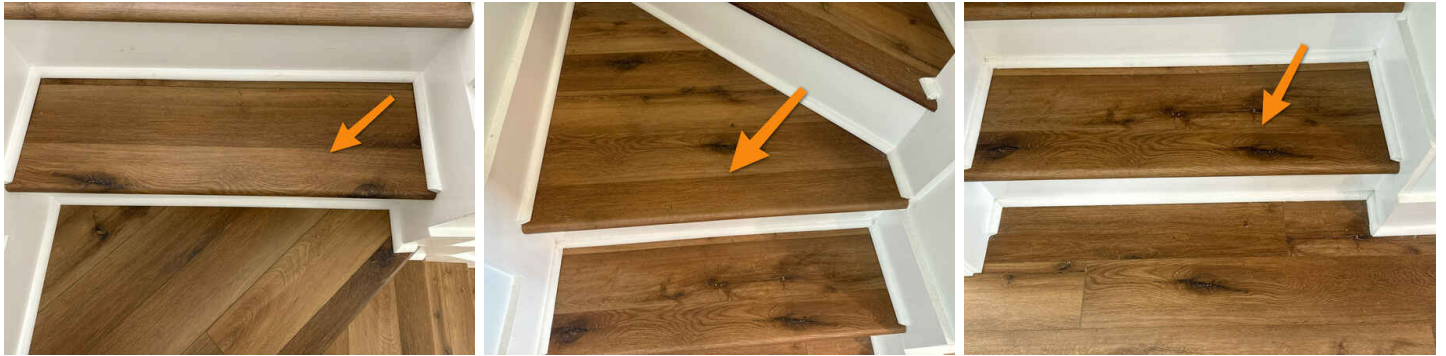
8.6.1 Stairs

Repair Needed

Contact a qualified professional.

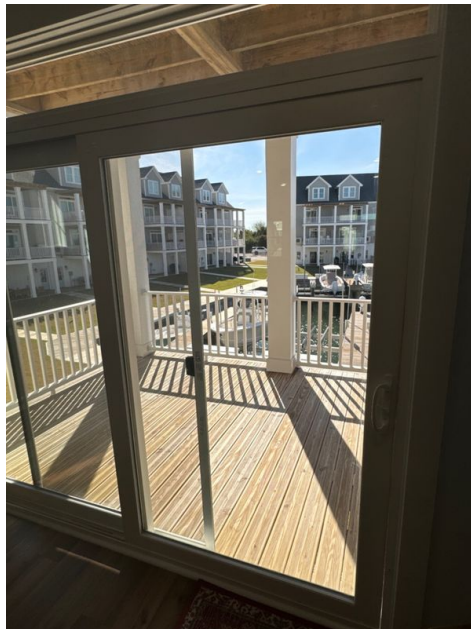
17.6.1 Sliding Glass Door

SLIDING GLASS DOOR: NOT WORKING PROPERLY

Contact a qualified professional.

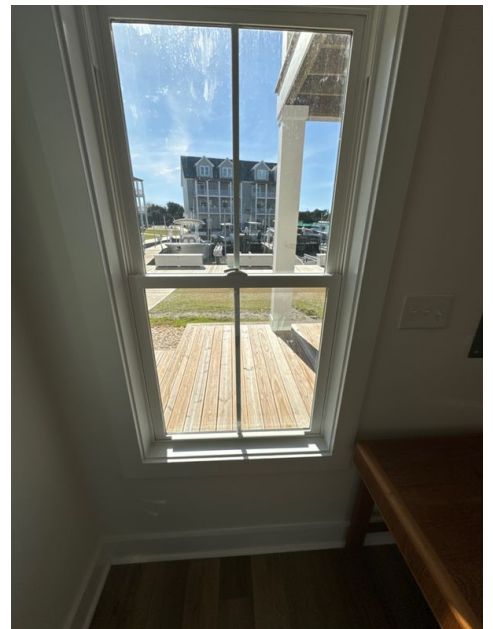
20.7.1 Windows

OPERATION - DIFFICULT TO OPERATE

Contact a qualified window repair/installation contractor.

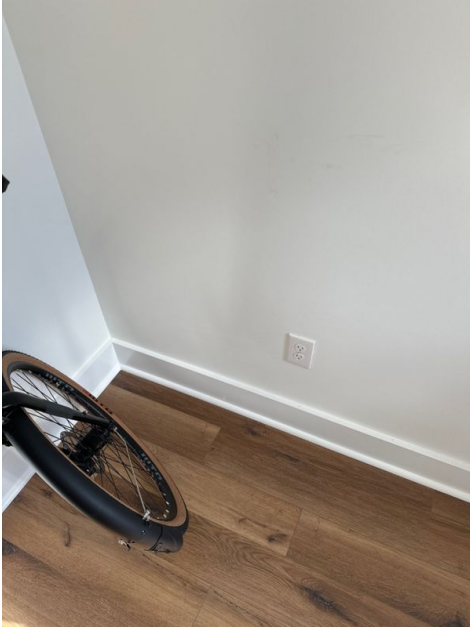
20.8.1 Receptacles

RECEPTACLE(S) - LOOSE AT WALL

Contact a qualified electrical contractor.

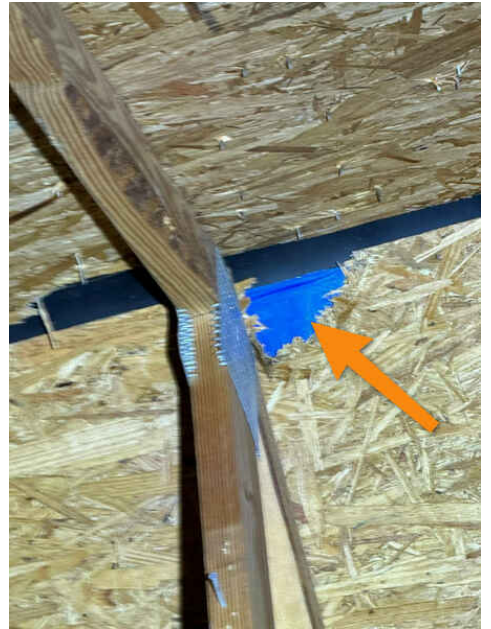
25.4.1 Roof Structure/Framing

SHEATHING DAMAGED

Contact a qualified professional.
