2theCore Home Inspections

## 2THECORE RESIDENTIAL INSPECTION

123 Sample Street, Demo City, ST 12345

5/28/2026 7:10AM

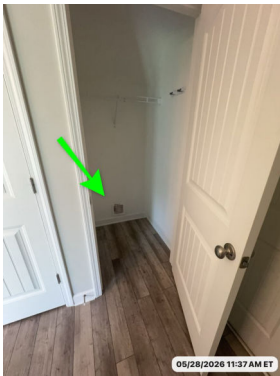
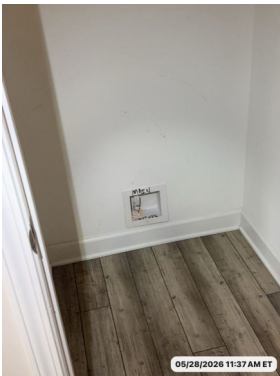
1st Floor Closet

##### 2.2.1 Water Shutoff Valve Location: Closet Under Stairs

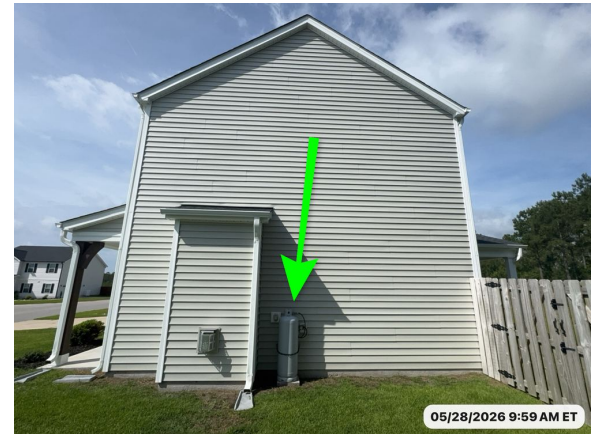
### 2.3.1 Main Gas Shutoff Valve Location: At LP Tank

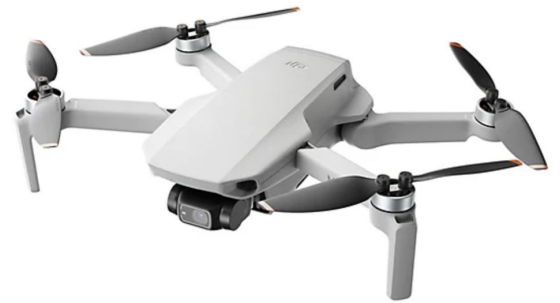
LMT - An aerial drone was used for the roof evaluation. It is understood that this method of inspection is not as thorough as if the roof surface was able to be walked, and is considered a limited inspection. Any comments made in this report relating to the roof covering, roof protrusions, gutters, chimneys, etc. are limited to the visible perspective of the drone. If a more thorough inspection is desired I recommend consulting a roofing contractor prior to the end of your inspection contingency.

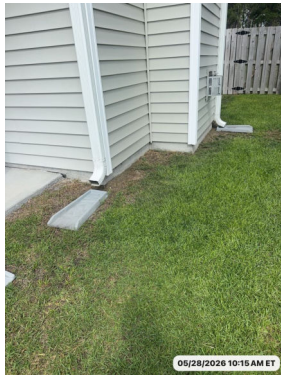
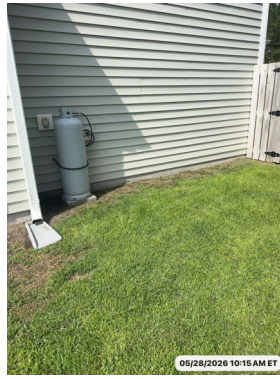
There are areas of improper grading that do not allow rainwater to drain away from the structure effectively. With a slab foundation, poor drainage can lead to water pooling against the home, increasing the risk of foundation settlement, soil erosion, and moisture intrusion through expansion cracks. Prolonged exposure to excessive moisture can also contribute to slab heaving, deterioration of exterior materials, and potential mold growth in adjacent walls. Recommend consulting a qualified general contractor to correct the grading to ensure proper water runoff and protect the foundation from long-term damage.

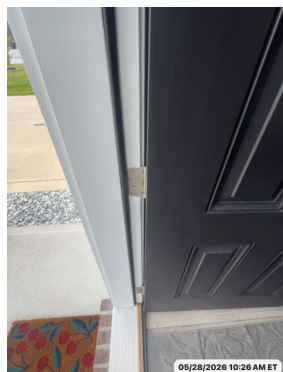
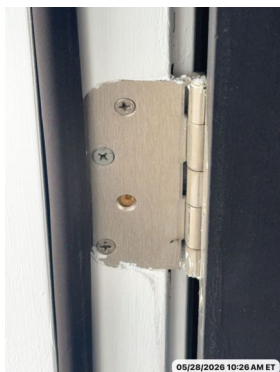
Front Door

There were one or more screws missing at the hinges at the time of the inspection. I recommend further evaluation and repair as needed.

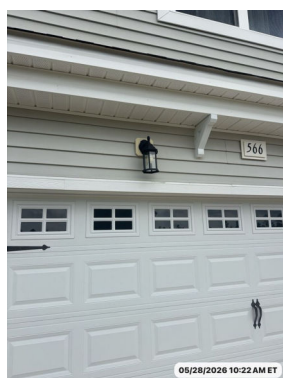
During the inspection, it was noted that a light fixture located on the exterior of the home was not properly secured to the electrical junction box. This presents a potential safety hazard as the fixture could become loose and fall, causing damage or injury. It is recommended that a licensed electrician be contacted to properly secure the fixture to the junction box to ensure its stability and safety.

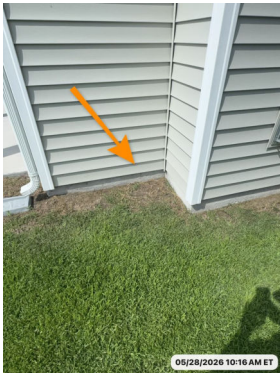
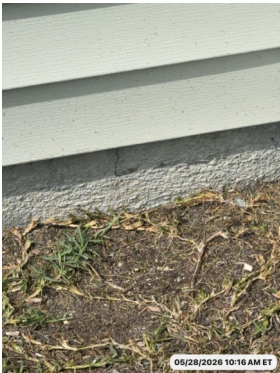
FYI - A crack was present at the referenced area of the slab. This crack did not contain an excessive crack width, and no lateral displacement was associated with the crack at the time of inspection. At a minimum this crack will need to be sealed with an appropriate material by a qualified contractor to prevent moisture infiltration and related damage. I recommend having a contractor evaluate the crack in context of looking over other slab concerns noted in this report.

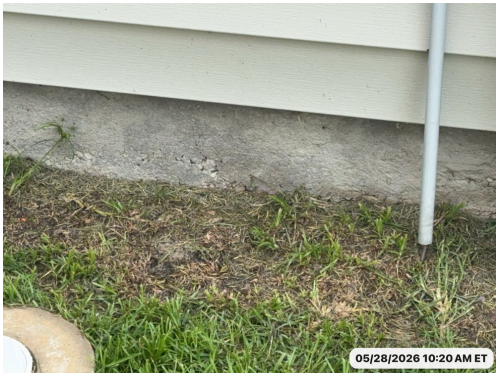
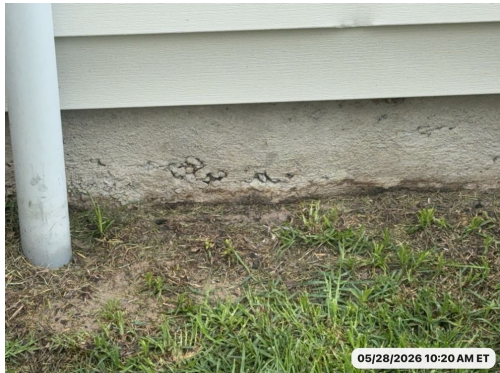
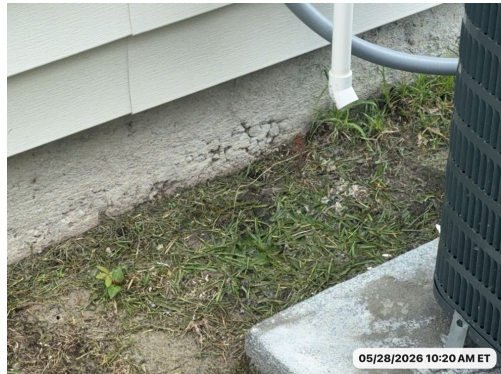
The slab was honeycombed at the referenced area(s). This can occur due to the composition of the concrete mix, leaving it in the vibrator too long, or other preparation errors. These openings in the concrete can allow for water infiltration into the slab, internally cracking it due to freeze thaw cycles, and pressure. An evaluation of the slab with repairs made as needed is recommended to be performed by a qualified concrete contractor.

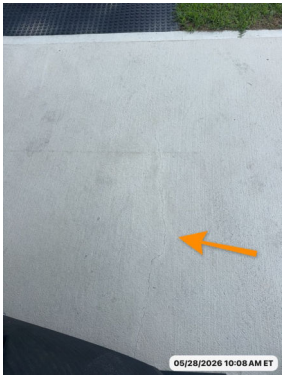
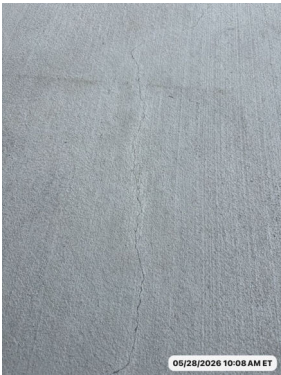
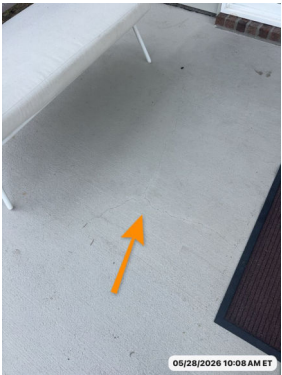
During the inspection, it was identified that there is cracking or settlement in the concrete porch or patio. This can be caused by a variety of factors such as poor soil preparation, inadequate drainage, or freeze-thaw cycles. Cracking or settling can cause the surface to become uneven and can be a trip hazard. It can also lead to further deterioration of the concrete if left unrepaired. It is recommended that a professional, such as a licensed contractor, evaluate the condition of the porch or patio and make any necessary repairs.

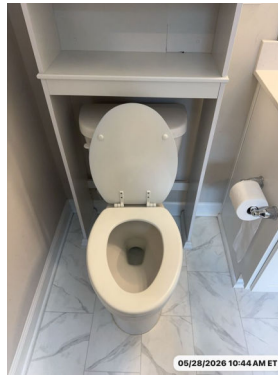
#### Loose toilet

#### 9.3.2 Toilet: Loose From Flange

During the inspection, it was noted that the toilet in the bathroom was loose from the flange, which is the ring that attaches the toilet to the floor. This can be caused by a variety of factors, such as the flange being improperly installed, the toilet being installed too tightly, or the flange being damaged or corroded. This condition can cause leaks and even the toilet to become unstable and potentially tip over, so it is recommended that a plumber be called to assess and repair the situation. Additionally, it is important to check the seal between the toilet and the floor to ensure that it is not allowing water to seep out and cause damage.

Recommendations

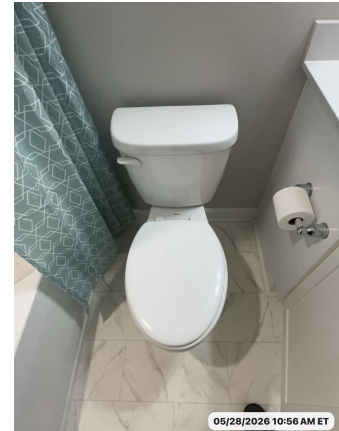
The toilet in the bathroom rocks when pressure is applied, indicating it is not securely fastened to the floor. This issue may be due to loose bolts, an uneven floor, or a deteriorated wax seal. Immediate repair is recommended to prevent potential water leaks and further damage to the flooring.

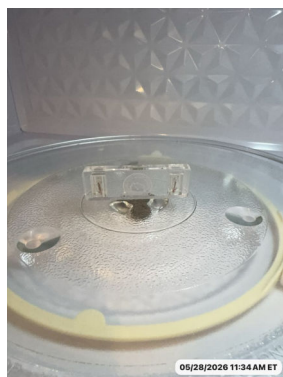
### 13.2.5 Microwave Oven Detector

I used a microwave oven detector to confirm the proper functionality of the microwave

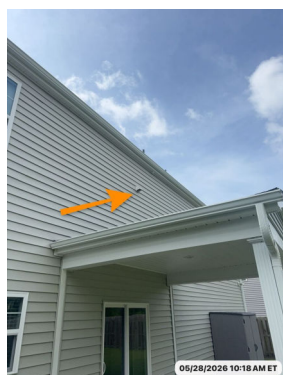
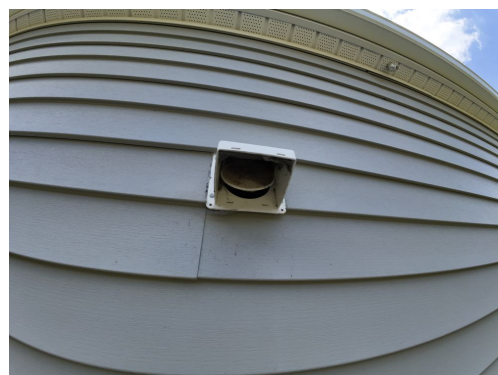
The backdraft damper was stuck open from the exterior cover. This can allow for wildlife or insect infiltration into the vent duct. Replacement of the flap and/or cover as needed is recommended by a qualified person.

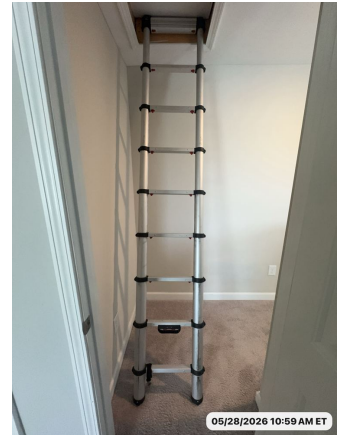
#### 15.2.1 Location: Hallway

*Attics can only be traversed if adequate space and flooring allows. If blown in insulation is present and floor can not be seen, then the inspector cannot walk in the attic for further review. And inspector cannot walk directly above framing without a solid floor such as plywood or OSB.*

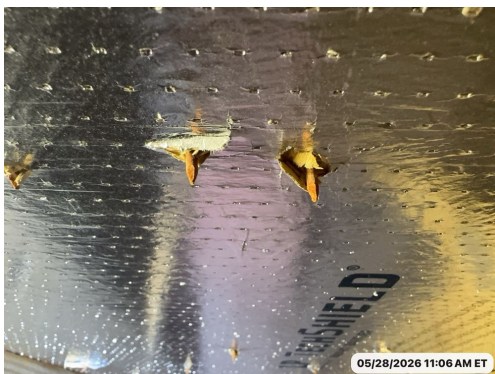
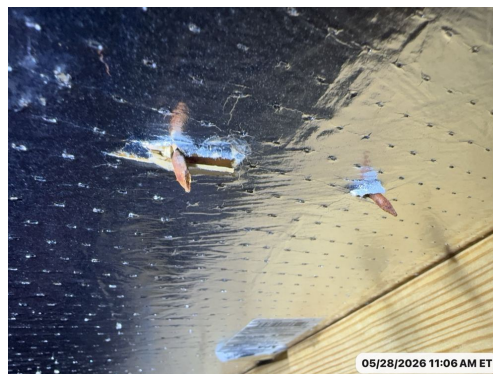
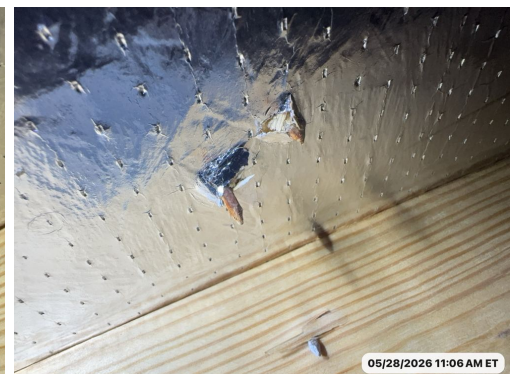
Rusted nail tips were observed protruding through the roof sheathing within the attic. This condition is commonly associated with elevated moisture levels, condensation, or inadequate attic ventilation and may also be influenced by HVAC-related humidity conditions. Prolonged moisture exposure can contribute to wood deterioration and potential concealed damage over time. Recommend further evaluation and corrective measures by a qualified contractor.

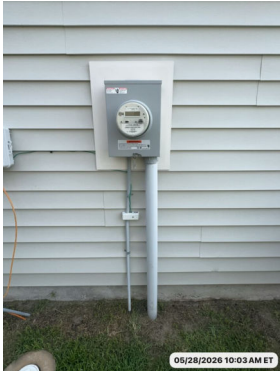
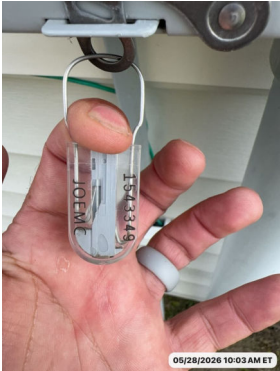
#### 17.2.1 Pictures

### 17.2.2 Description: Underground

Power was supplied to the home via an underground service lateral. The meter and conduit appeared to be in satisfactory condition. No deficiencies were observed at visible portions unless otherwise noted in this report.

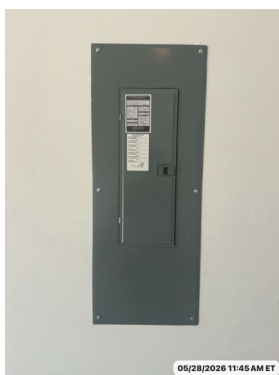
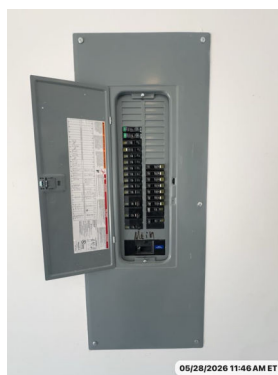
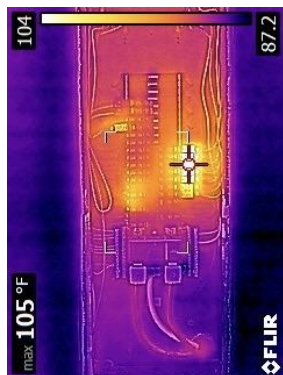
#### 17.4.1 Picture

#### 17.4.2 Service Panel Location: Garage

#### 17.4.3 Manufacturer: Square-D

The service disconnect or main OCPD (over current protection device) was inspected looking for any deficiencies and reporting on its location. This disconnect can be a breaker, fuse block, or kill switch. This is the means of shutting off all electricity entering the home.

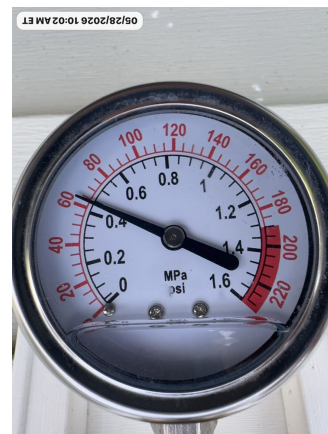
### 18.2.1 Water Pressure (Approx.): 60-70psi

The home's water pressure was checked at the time of the inspection and recorded as an approximate reading. Water pressure can vary depending on municipal supply, well system performance, fixture use, and other conditions present at the time of testing. This information is provided as a general reference for the client and reflects conditions observed during the inspection only. If water pressure concerns develop, further evaluation by a qualified plumbing contractor is recommended.

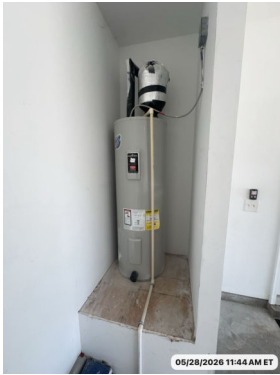
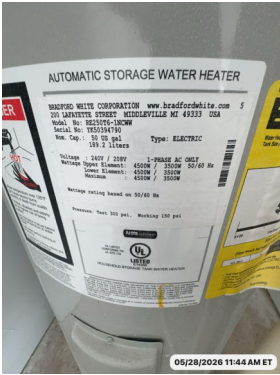
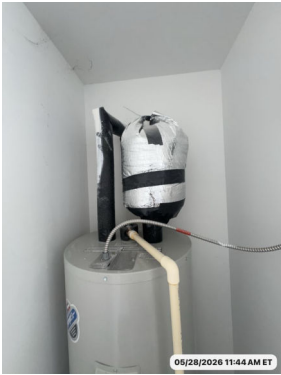
#### 19.1.1 Picture

#### 19.1.2 Water Heater Manufacturer: Bradford White

#### 19.1.3 Capacity: 50 Gallons

The water heater was inspected by looking at the overall condition of the unit, its power source, the water pipes, etc., and that it produced heated water at the time of inspection. No reportable deficiencies were visibly present with the unit unless otherwise noted in this report.

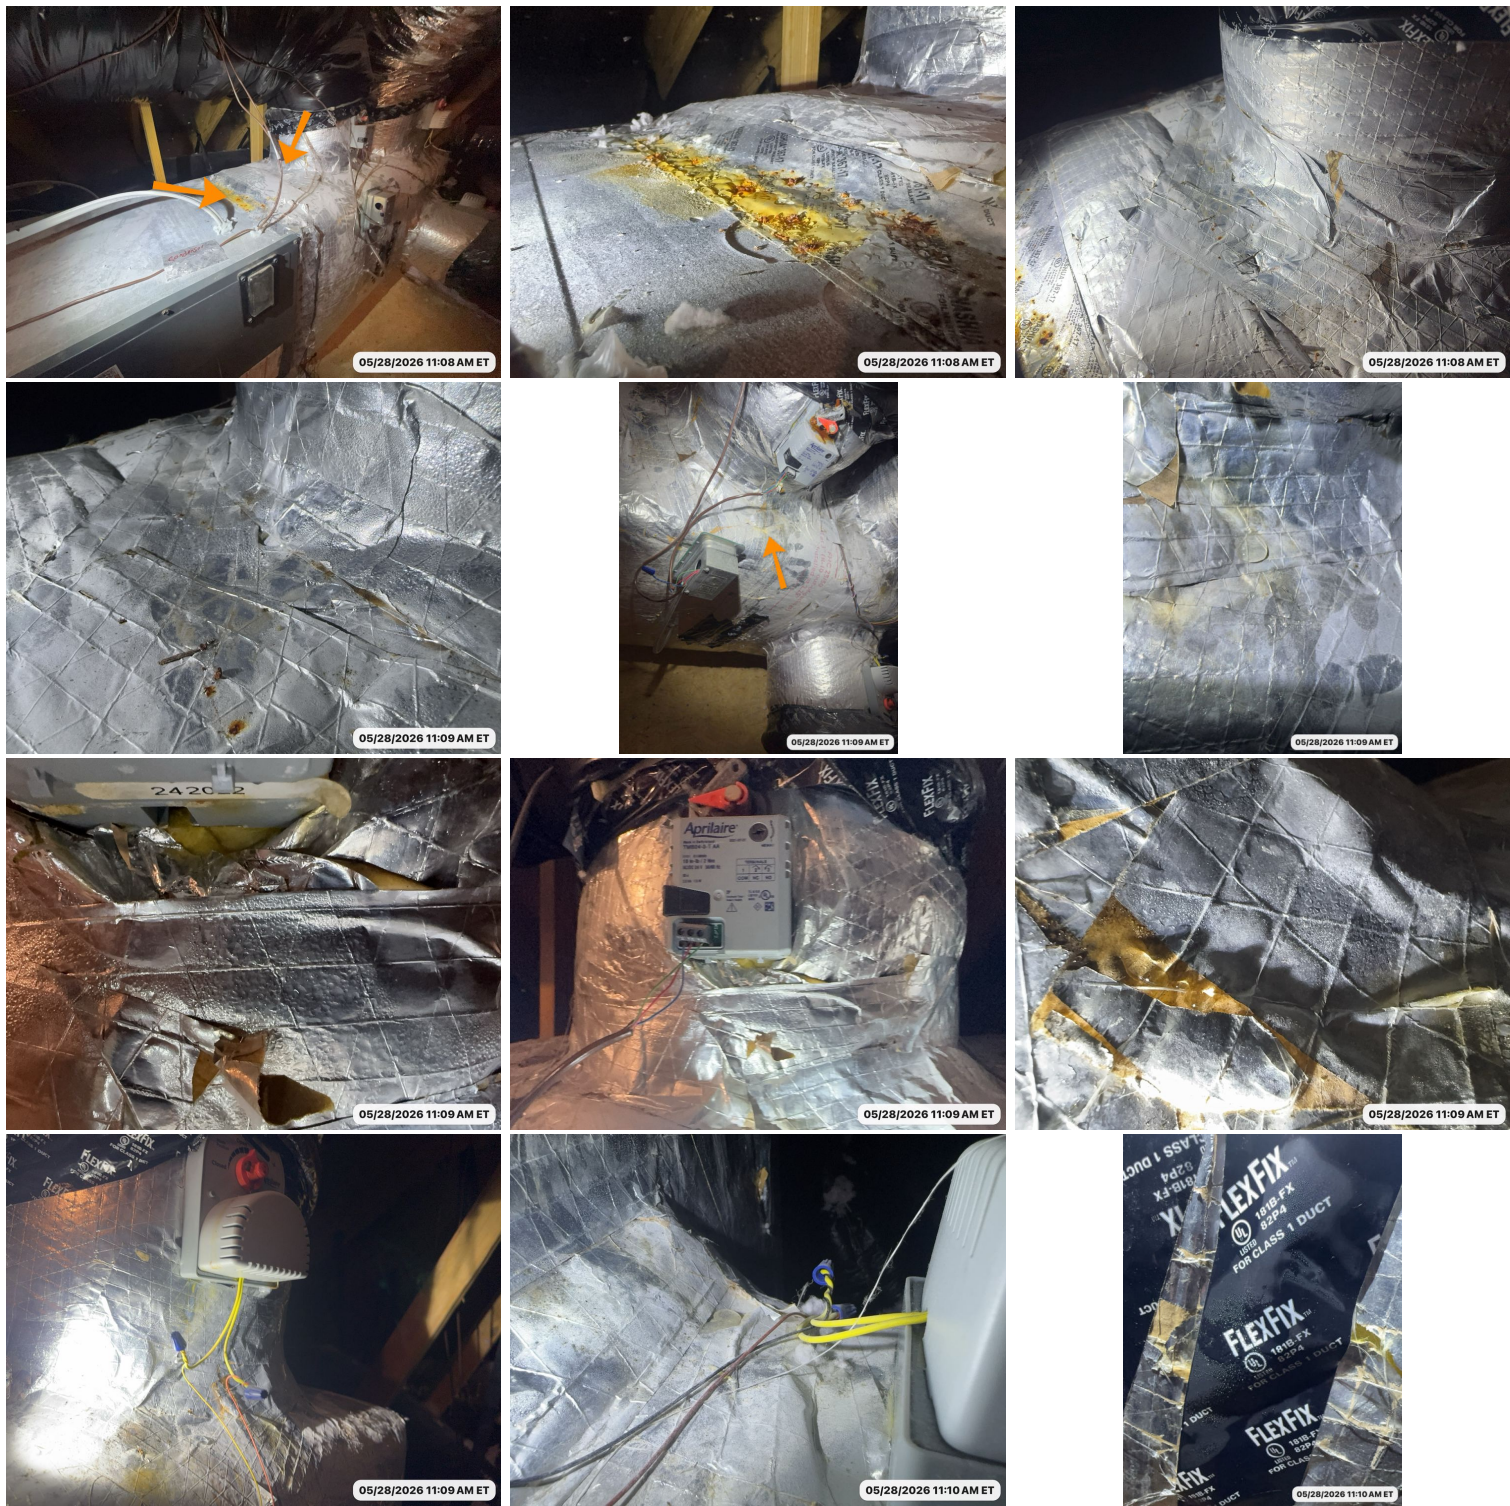
During the home inspection, moisture was observed at the air handler where the supply duct connects. This suggests a potential condensation issue that could lead to mold growth or damage if not addressed promptly. Further evaluation by a qualified HVAC technician is recommended to assess and resolve the source of moisture infiltration.

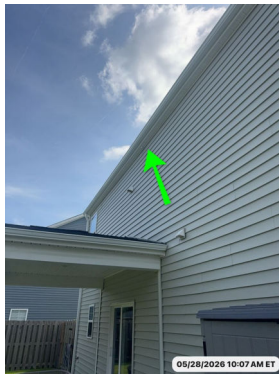
#### 21.4.3 Auxiliary Drain Pan - Drain Pipe

An auxiliary drain pan was observed with a drain line routed to the exterior. No deficiencies were noted at the time of the inspection unless otherwise indicated elsewhere in this report.

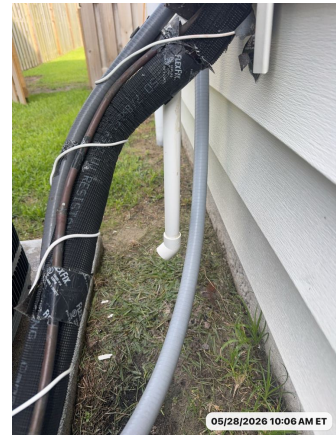
### 21.5.1 Condensate Drain Termination Point: Left Side of Home

*The condensate drain termination point was observed at the time of inspection. This is the location where moisture removed from the cooling system is discharged. Proper termination helps direct water to an appropriate area and can reduce the chance of moisture-related concerns. The visible termination point should be monitored and maintained to help ensure continued drainage performance.*

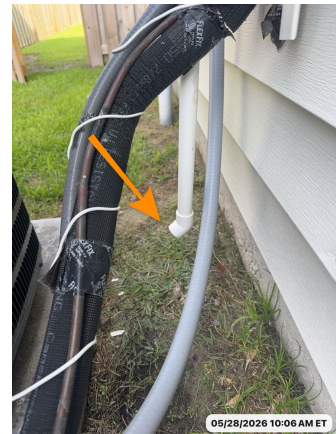
The condensate drain pipe or tubing terminated at or near the foundation of the home. This can allow water to saturate the soil in this area, possibly entering back into or under the structure. Extending the drain, away from the foundation, is recommended to be conducted by a qualified person.

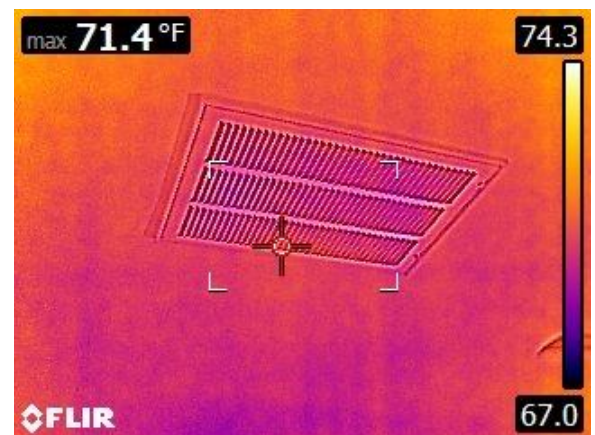
#### 21.8.1 Return Air Temp - Main Level: 70-75

A temperature reading of the return air was taken at the time of inspection to provide a baseline to compare output temperatures to, showing the system(s) responded to normal operating controls.

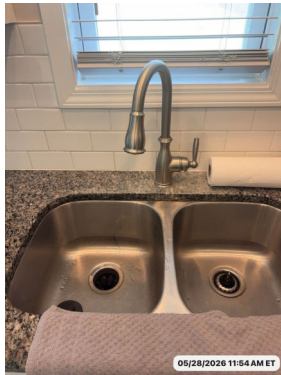
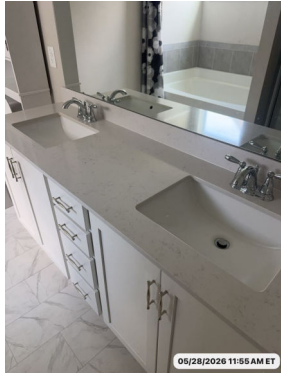
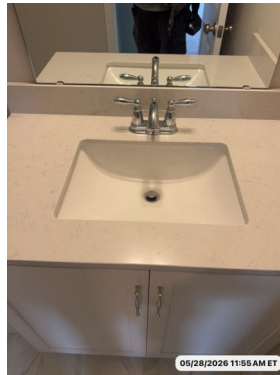
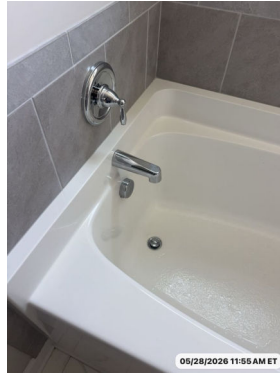
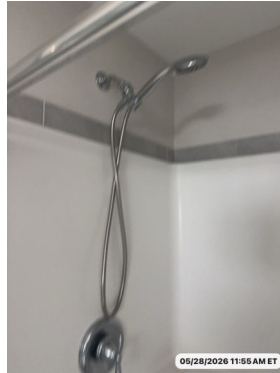
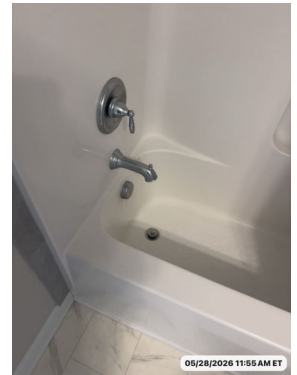
23.2.1 Water Fixtures Off

All water fixtures in the home were left in the off position after testing.

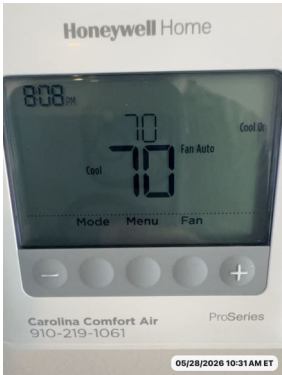
23.5.1 Photo Of Thermostat Before Testing

2nd Floor
