2THECORE HOME INSPECTIONS

2THECORE RESIDENTIAL

1234 Main Street
Cape Carteret, NC 28584

Buyer Name
11/28/2023 9:00AM

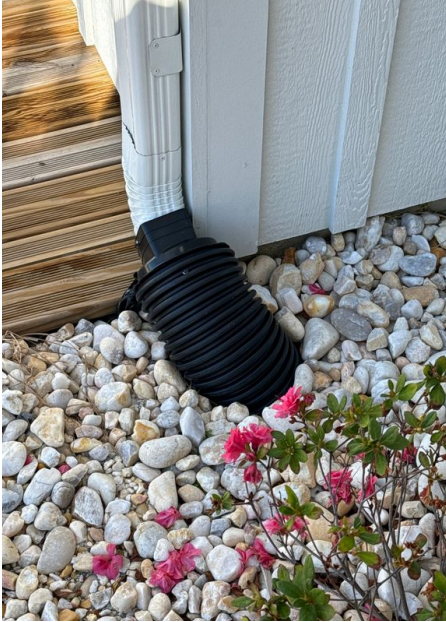
Gutters/Downspouts: Downspouts Terminated Below Grade

Some downspouts terminated below grade. Their connection to a drain tube could not be confirmed.

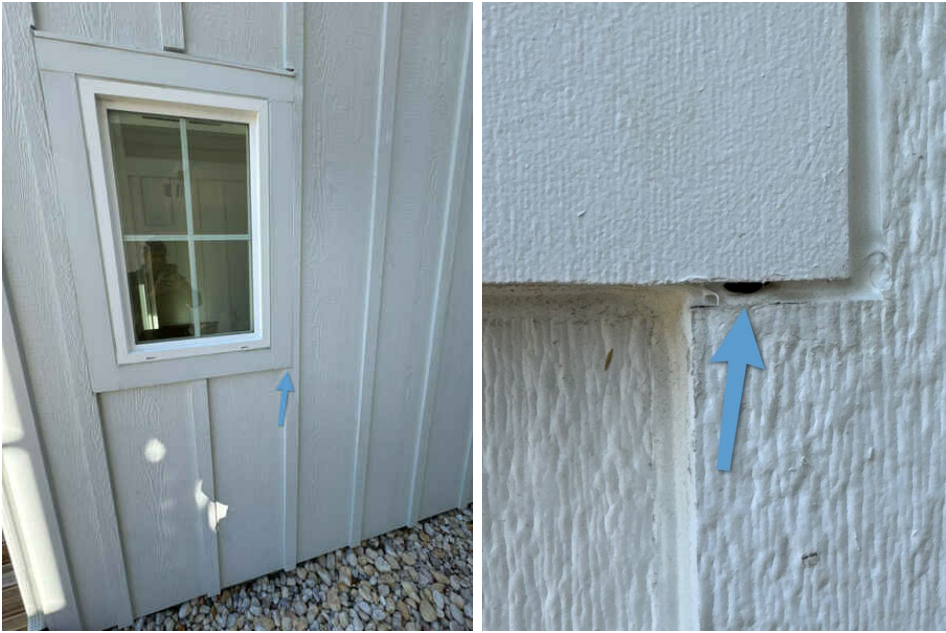
5.9.1 Sealant/Paint Overall

Maintenance Item

Recommendation

Contact a handyman or DIY project

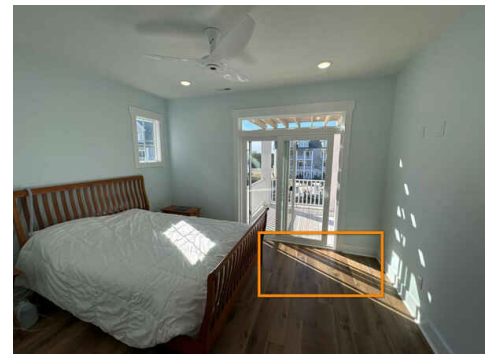
9.3.2 Floors

FLOOR(S) - OUT OF LEVEL AREA PRESENT

Recommendation

Contact a qualified flooring contractor

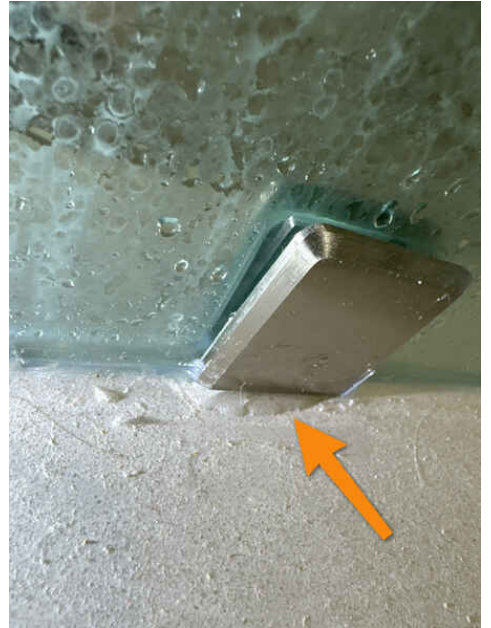
10.8.1 Shower Doors/Enclosures

Repair Needed

Recommendation

Contact a qualified professional.

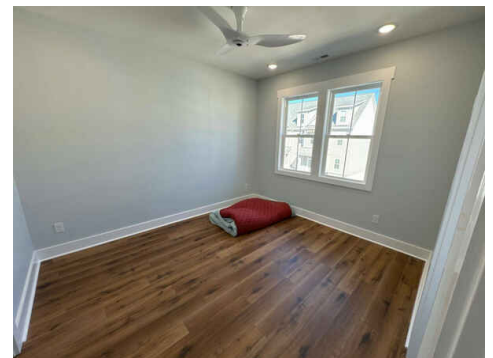
11.3.1 Floors

The sub floor was not level. There was a noticeable difference of 3/4 inch from left to right, and it was quite evident that the floor was bowed. An evaluation of this area to determine the cause along with repairs made as needed is recommended to be performed by a flooring contractor.

Contact a qualified flooring contractor

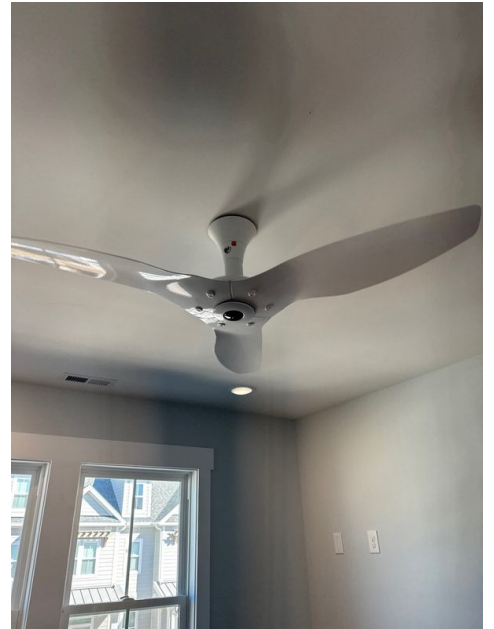
11.9.1 Ceiling Fans

WOBBLING - MINOR

The ceiling fan wobbled slightly during operation. The fan may be out of balance. Repairs are recommended to be conducted as needed by a qualified person to eliminate any wobbling.

Contact a qualified handyman.

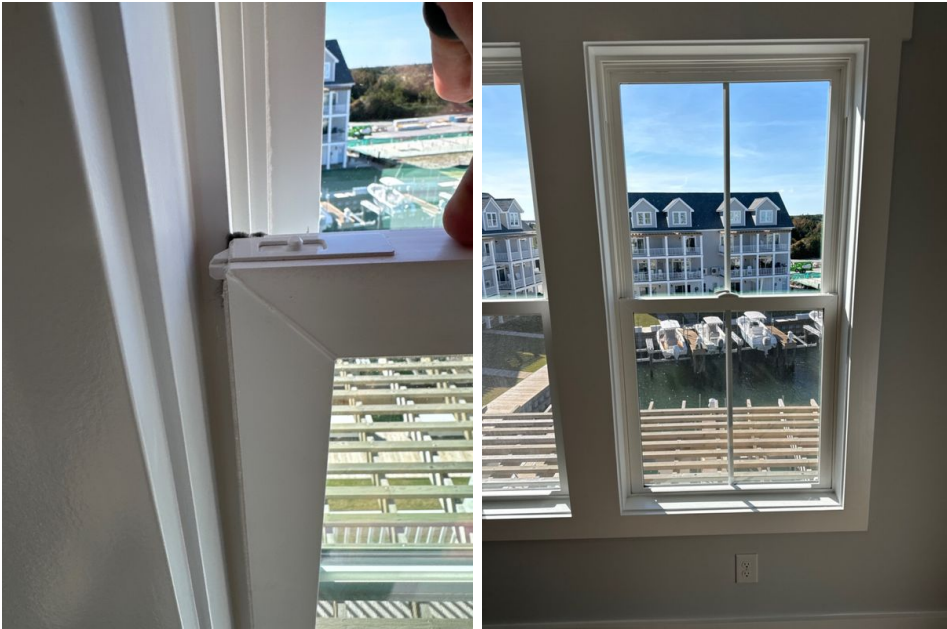
12.6.1 Windows

The window(s) in the referenced area(s) were not functioning properly at the time of inspection. Repairs are recommended to be conducted as needed for proper operation by a window contractor or other qualified person.

Contact a qualified window repair/installation contractor.

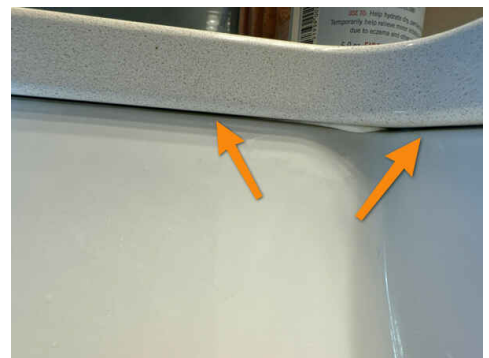
Gaps and or missing sealant were present where the sink transitions to the countertop. I recommend sealing around the sink as needed to prevent water / moisture infiltration.

Contact a qualified professional.

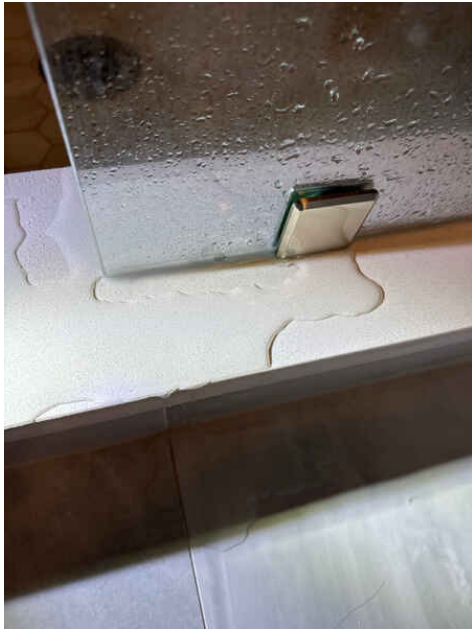
13.8.1 Shower Doors/Enclosures

ENCLOSURE - LEAKING

There were leaks around the glass shower enclosure. Repairs are recommended to the enclosure as needed to rectify any leaks.

Contact a qualified professional.

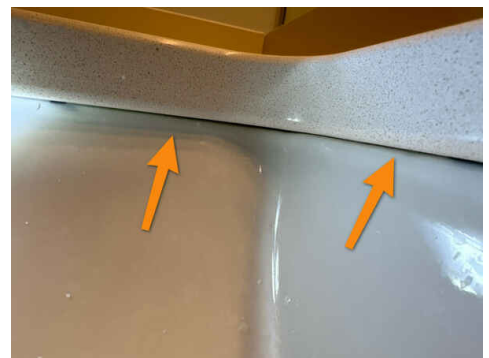
Repair Needed

Contact a qualified professional.

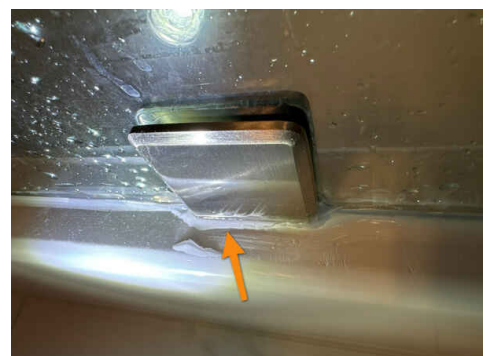
14.8.1 Shower Doors/Enclosures

ENCLOSURE - LEAKING

Contact a qualified professional.

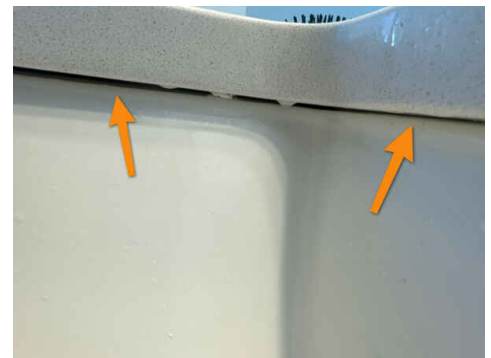
Repair Needed

Contact a qualified professional.

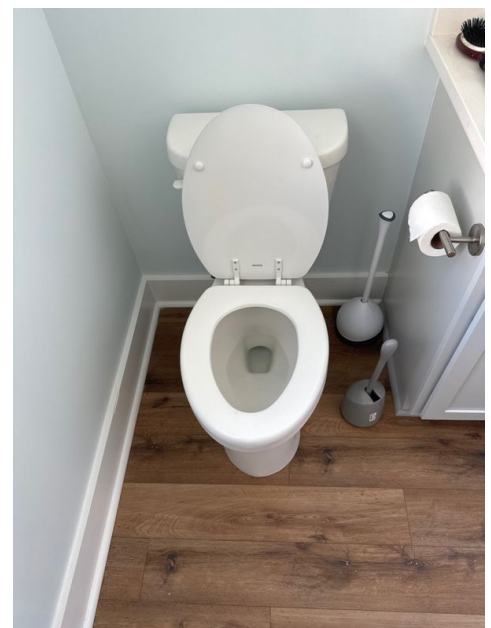
15.6.1 Toilet(s)

Repair Needed

Contact a qualified plumbing contractor.

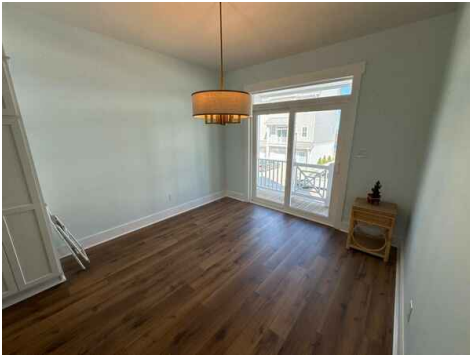
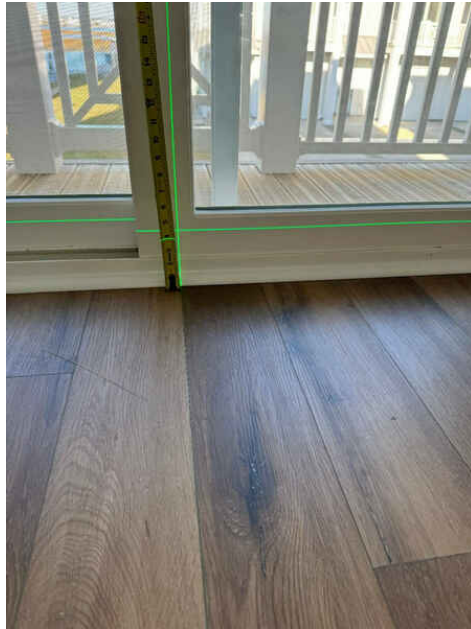
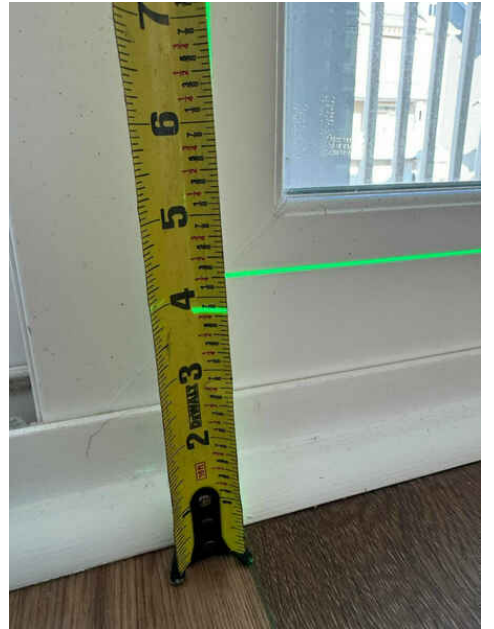
16.2.1 Floors

middle of door

Contact a qualified flooring contractor

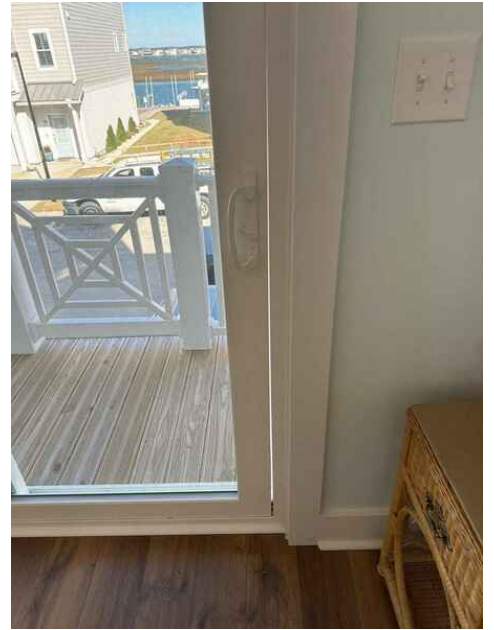
16.5.1 Sliding Glass Door

The sliding door panels were not functioning properly. Repairs are recommended to be performed as needed for proper operation by a qualified person.

Contact a qualified professional.

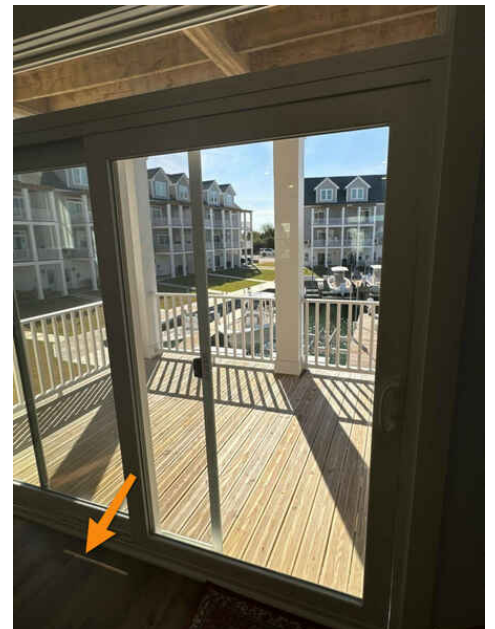
A portion of the flooring was not level. An evaluation of this area to determine the cause along with repairs made as needed is recommended to be performed by a flooring contractor.

Contact a qualified flooring contractor

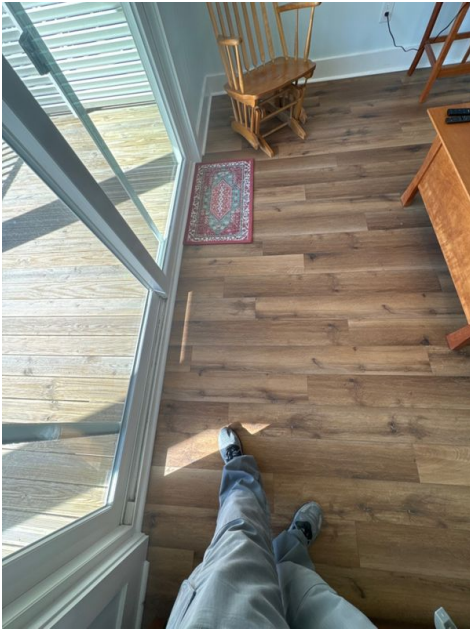
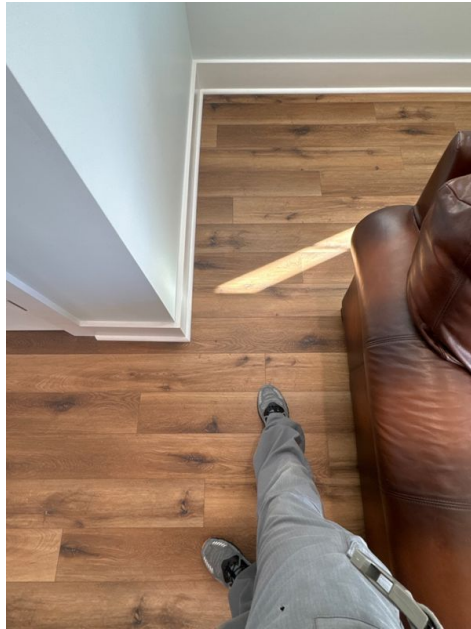
17.2.2 Floors

A "soft area" was present on the referenced area of the floor, and a cause could not be determined. An invasive evaluation of the area(s) and repairs made as needed is recommended to be performed by a qualified contractor.

Contact a qualified professional.

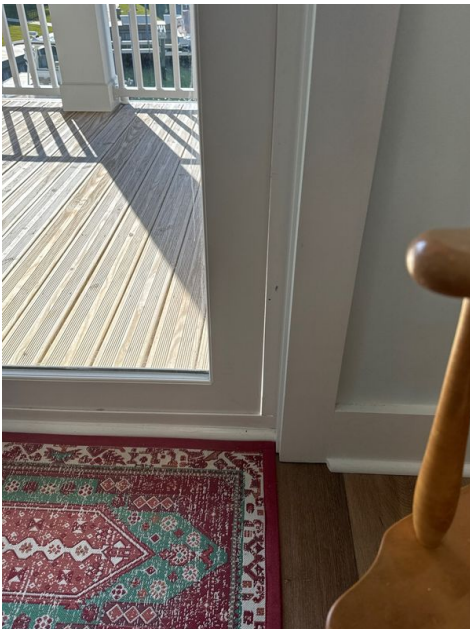
17.6.1 Sliding Glass Door

SLIDING GLASS DOOR: NOT WORKING PROPERLY

The sliding door panels were not functioning properly. Repairs are recommended to be performed as needed for proper operation by a qualified person.

Contact a qualified professional.

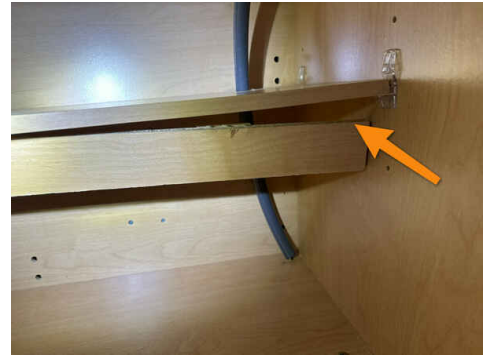
18.2.1 Countertops & Cabinets

CABINETS DAMAGED

Cabinets had visible damage at time of inspection. Recommend a qualified cabinets contractor evaluate and repair.

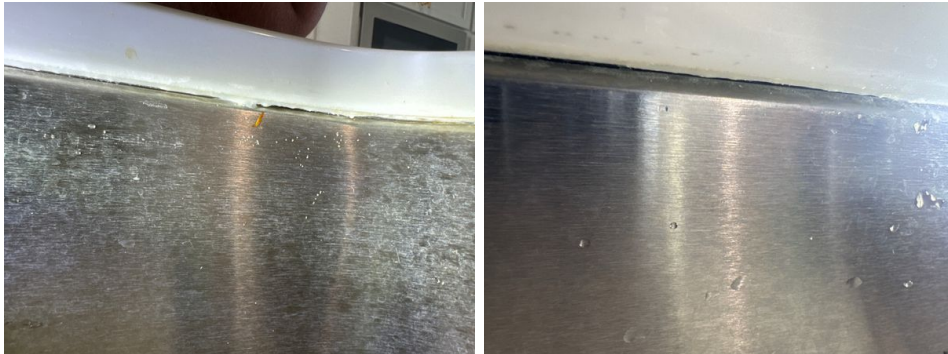
18.5.1 Sink(s)

SEALANT - GAPS PRESENT

Gaps were present where the sink transitions to the countertop. I recommend sealing around the sink as needed to prevent water / moisture infiltration.

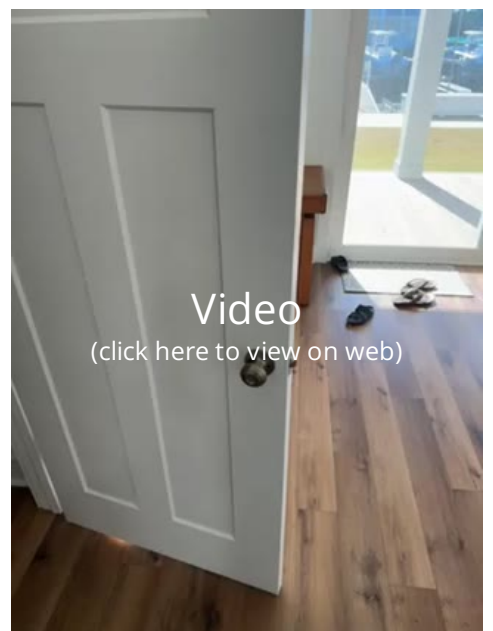
20.2.1 Doors

The referenced door(s) opened or closed on their own, and may be out-of-plumb. Adjustments or modifications to the door(s) as needed for proper operation is recommended to be conducted by a qualified person.

Contact a qualified handyman.

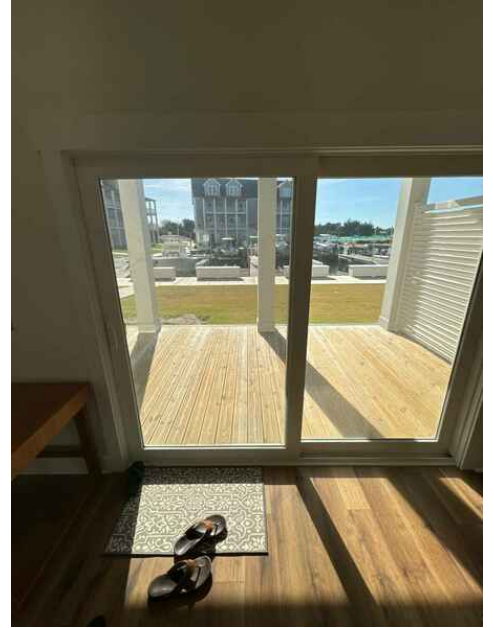
20.3.2 Floors

Repair Needed**FLOOR(S) - SOFT AREA PRESENT**

A "soft area" was present on the referenced area of the floor, and a cause could not be determined. An invasive evaluation of the area(s) and repairs made as needed is recommended to be performed by a qualified contractor.

Recommendation

Contact a qualified professional.

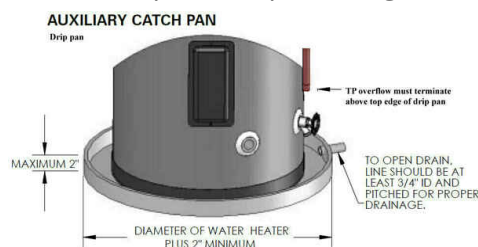
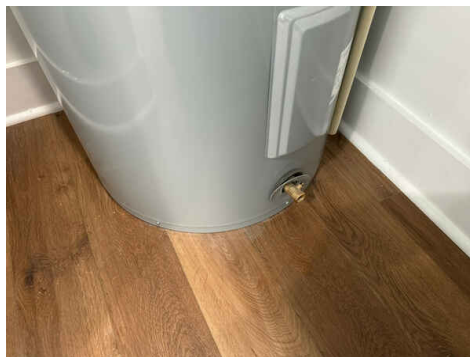
21.1.1 Water Heater Condition

DRAIN PAN - MISSING

A water heater drain pan was not present. Drain pans also called "Smitty pans" are recommended when the water heater is installed in an area where leaks from the unit could cause damage to framing components and/or interior areas. The installation of a drain pan is recommended to be conducted by a qualified person.

Recommendation

Contact a qualified plumbing contractor.

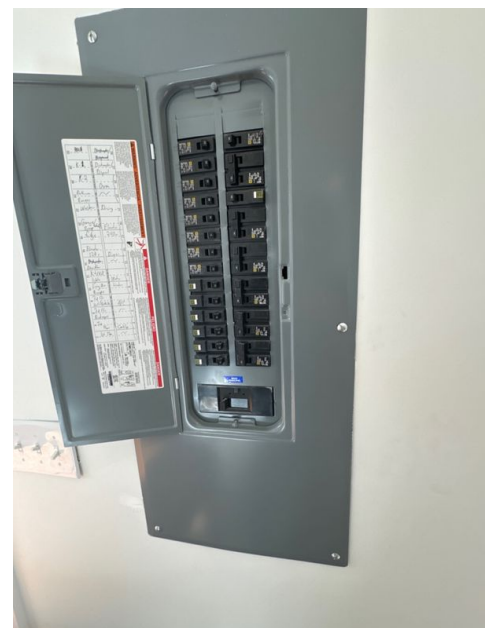
The panel cover was very "tight" due to surrounding drywall and did not fit back onto the panel properly, preventing the installation of two screws. Modifications to the drywall for proper fitment of the cover is recommended to be performed by a licensed electrician.

Recommendation

Contact a qualified electrical contractor.
